STRUCTURAL CONDITION SURVEY

LAND REUTILIZATION AUTHORITY
OWNED PORTION
of
CARTER CARBURETOR FACILITY
ST. LOUIS, MISSOURI

JULY 1995

**TapanAm Associates, Inc.
Leawood, Kansas and
Kansas City, Missouri
For
U.S. Environmental Protection Agency
Region VII
Kansas City, Kansas**

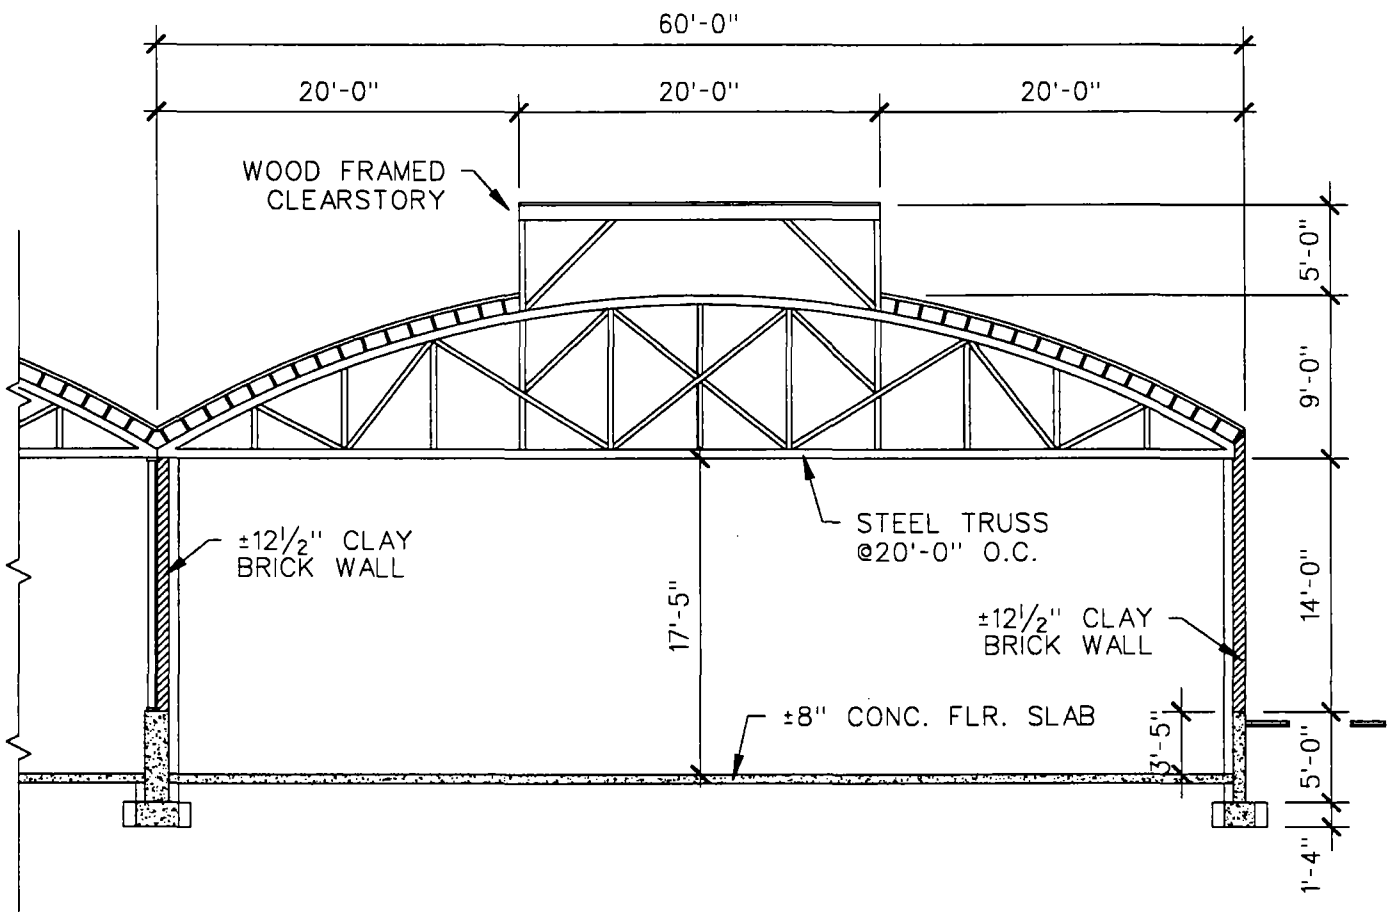
FIGURE 3
NORTH DIE CAST
BUILDING
SECTION

The North Die Cast building is a long narrow building having a column free floor area. The finish floor is lower than the outside grade and is accessed by stairs. A clearstory above at the roof provided natural lighting to the floor below. A section of the building is shown in Figure 3.

The roof is a built-up system consisting of felt and gravel over timber decking. The roof framing consists of timber joists spanning between roof trusses the length of the building. A clearstory spans across the top of the roof trusses down the center of the building. The clearstory is framed with timber sidewalls having full height windows (glass, frame and sash). Likewise, the clearstory roof framing consists of timber joists and decking with a built-up roof covering. (Photo No. 8)

The primary framing consists of masonry bearing walls and steel roof trusses spaced at 20 feet on center. The roof truss configuration is a bowstring truss fabricated from structural steel

angles. The trusses span the width of the building bearing on a solid clay brick wall at both the north and sides of the building. (Photo Nos. 7 and 8)

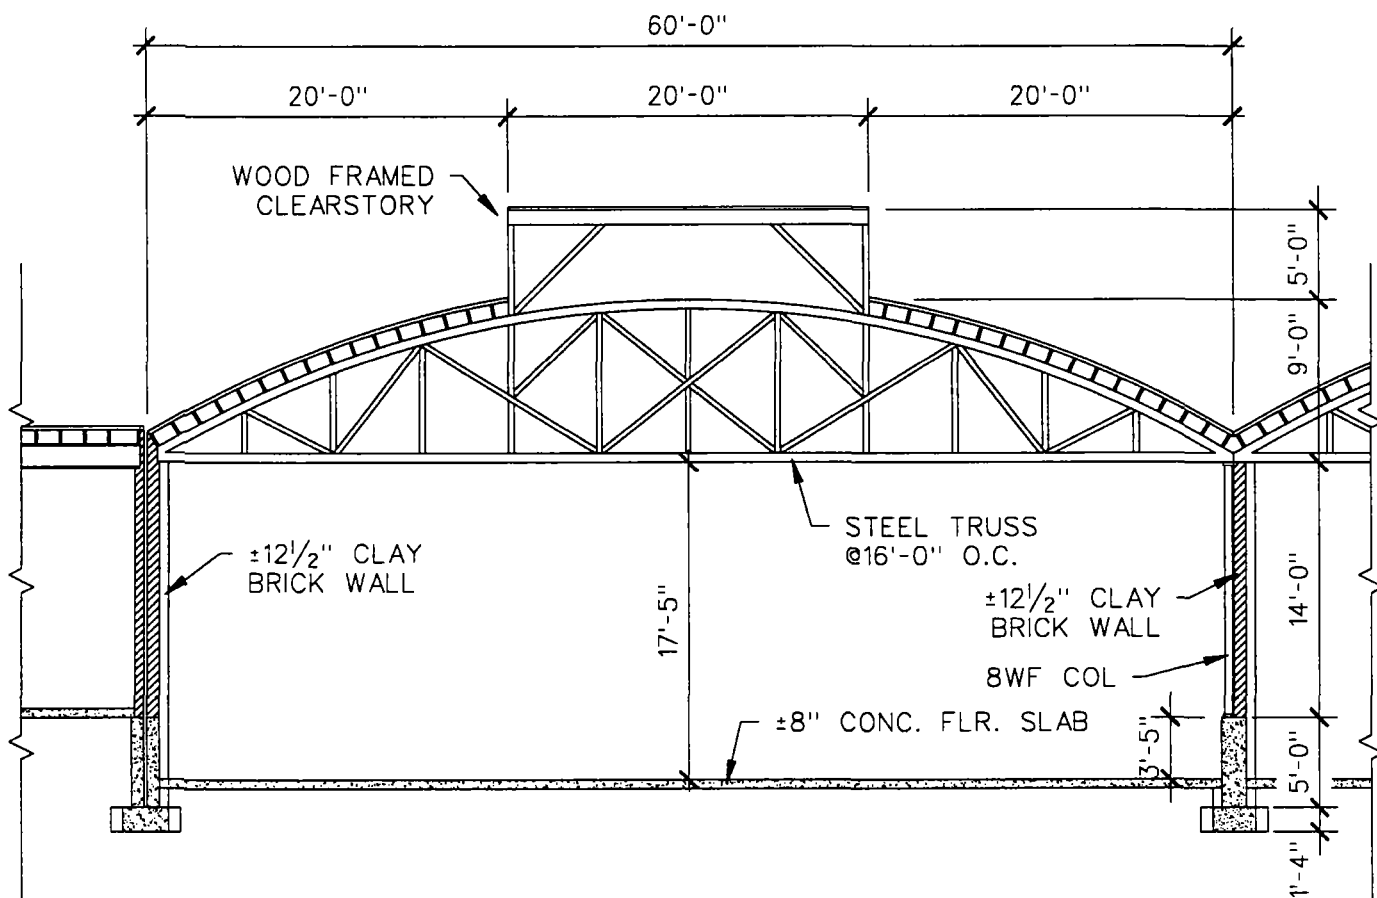
FIGURE 4
SOUTH DIE CAST
BUILDING
SECTION

The South Die Cast building is a long narrow building having a column free floor area. The finish floor is lower than the outside grade and is accessed by stairs. A clearstory above at the roof provided a natural lighting to the floor below. A section of the building is shown in Figure 4.

The roof is a built-up system consisting of felt and gravel over timber decking. The roof framing consists of timber joists spanning between roof trusses the length of the building. A clearstory spans across the top of the roof trusses at the center of the building. The clearstory is framed with timber sidewalls having full height windows (glass, frame, and sash). Likewise, the clearstory roof framing consists of timber joists and decking with a built-up roof covering. (Photo Nos. 9, 10 and 12)

The primary framing consists of masonry bearing walls and steel roof trusses spaced at 16 feet on center. The roof truss configuration is a bowstring truss fabricated from structural steel angles. The trusses span the width of the building bearing on a clay brick masonry wall along

the south side and supported by a wide flange (WF) column and reinforced concrete pier combination at the common wall with the North Die Cast Building. (Photo No. 11)

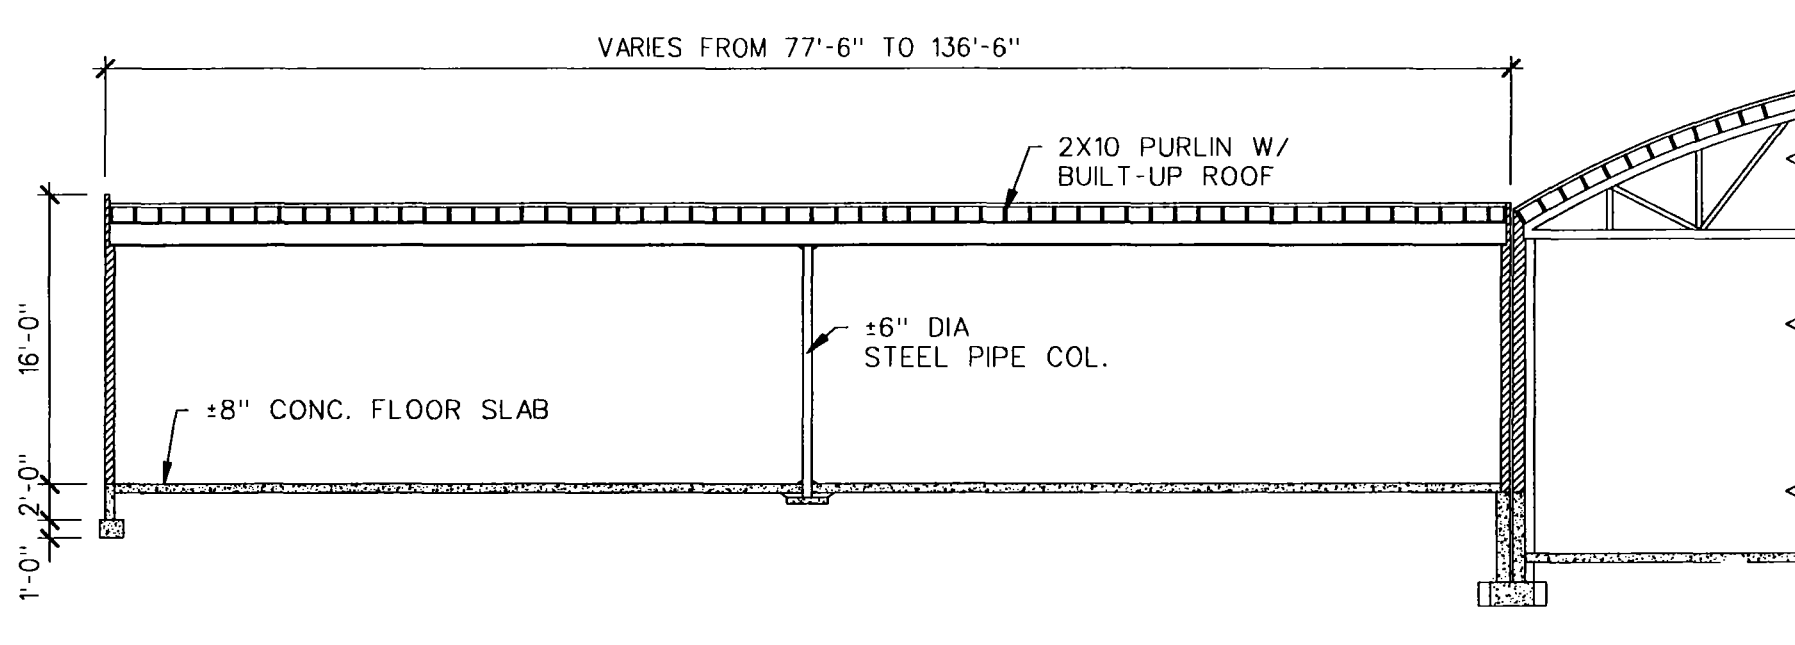
FIGURE 5
WAREHOUSE/OFFICE
& SHOP BUILDING
SECTION

The Warehouse/Office/Shop Building is a single story structure with the finish floor at grade. Exterior walls are a combination of solid clay brick and concrete masonry units. Skylights provided natural lighting to the floor below. A section of the building is shown in Figure 5.

The building roof is a built-up system consisting of felt and gravel over timber plank decking and joists at 16 inches on center spanning to beams supported by the perimeter walls and interior columns. Large openings have been framed for what were skylights. (Photo Nos. 14 and 15)

The primary framing consist of brick masonry bearing walls, rolled steel beams and columns. The common wall with the South Die Cast Building is a cavity type wall with the primary framing bearing on single wythe of brick and separate foundation stem walls. (Photo Nos. 13, 14, 15 and 16)

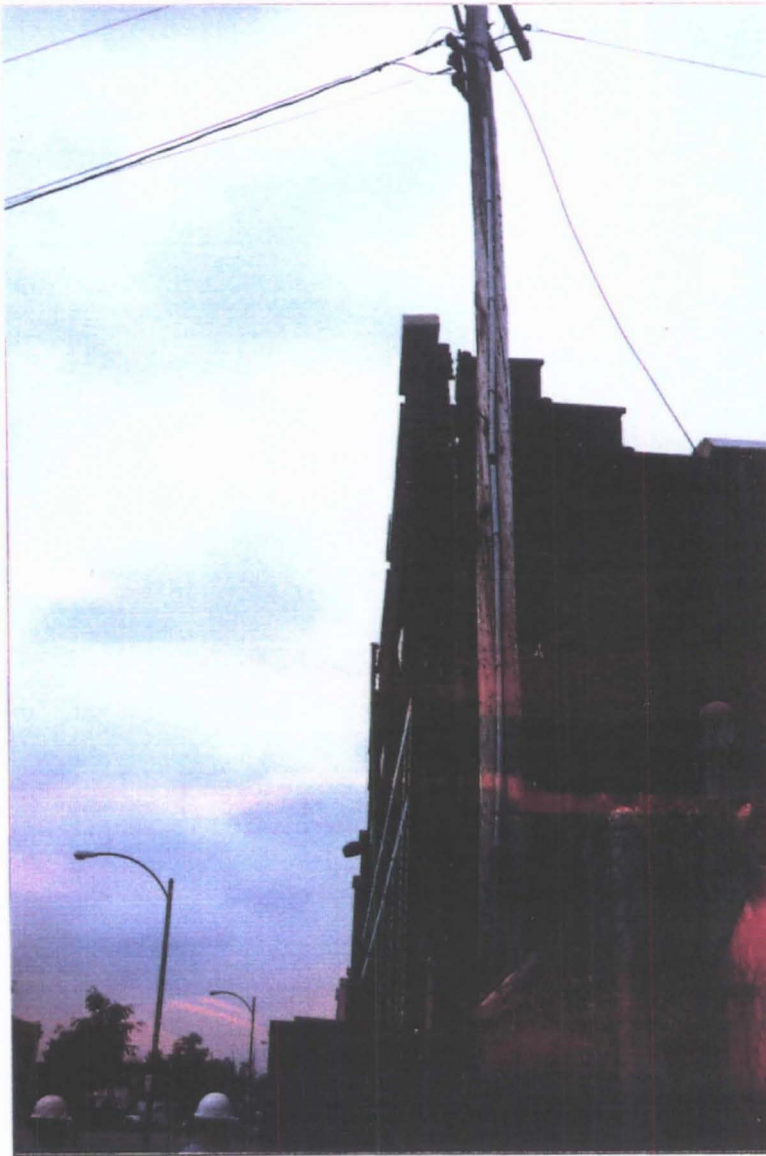
No. 1

East Side: Locations where brick parapet has separated from backing walls (NE Corner) and center pier

North Die Cast Building: View of Parapet pulled away from north exterior wall

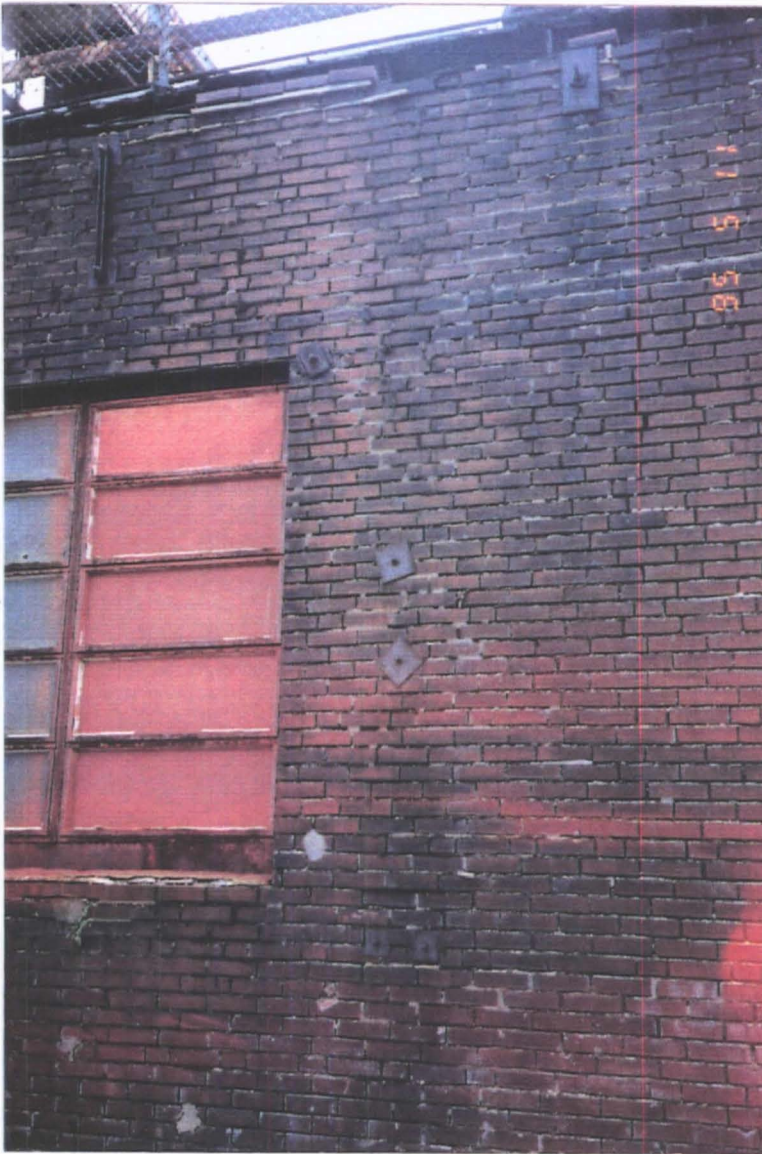
No. 3

The exterior surfaces of the masonry walls show deterioration of the mortar joints due to exposure to the elements and its age. The masonry shows its age by the mortar joints. The mortar joints have softened and are recessed from brickface allowing for moisture penetration into the brick wall. (Photo Nos. 3 and 4)

North Die Cast Building: View of brick masonry, missing brick at case and fascia trim board

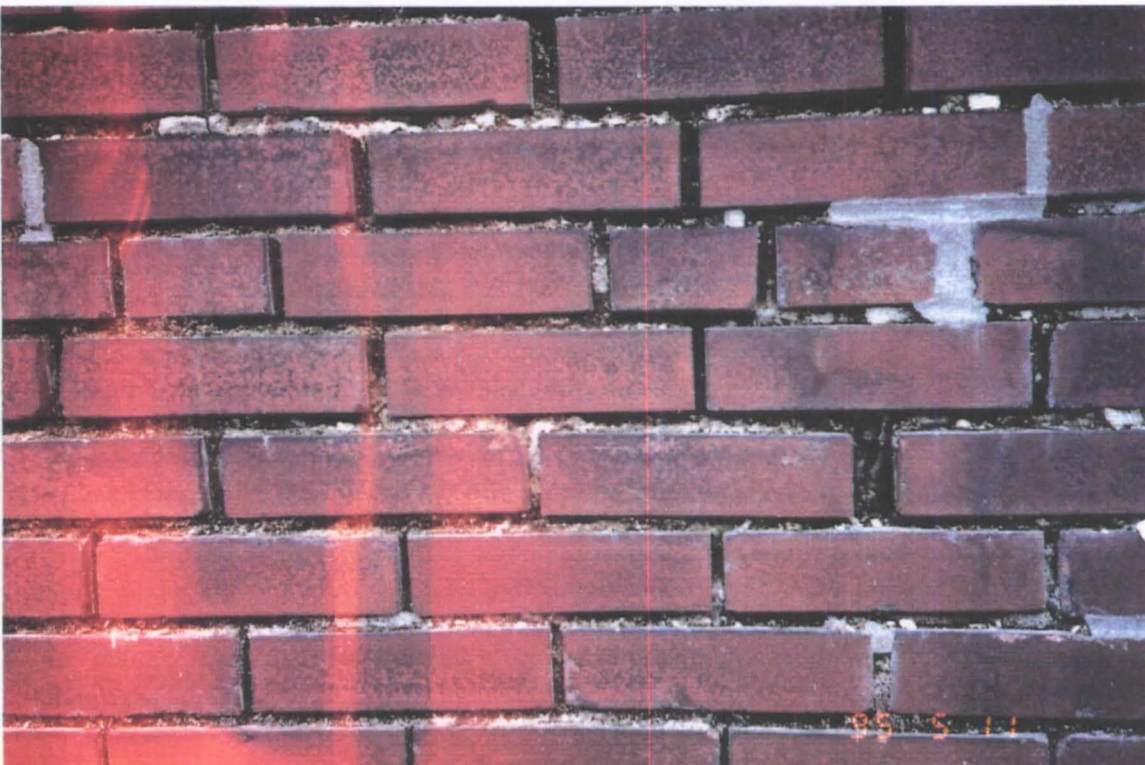
No. 4

Mortar joints extreme deterioration, with moss growing in joints

North Die Cast Building: View of mortar joints on exterior face of masonry wall

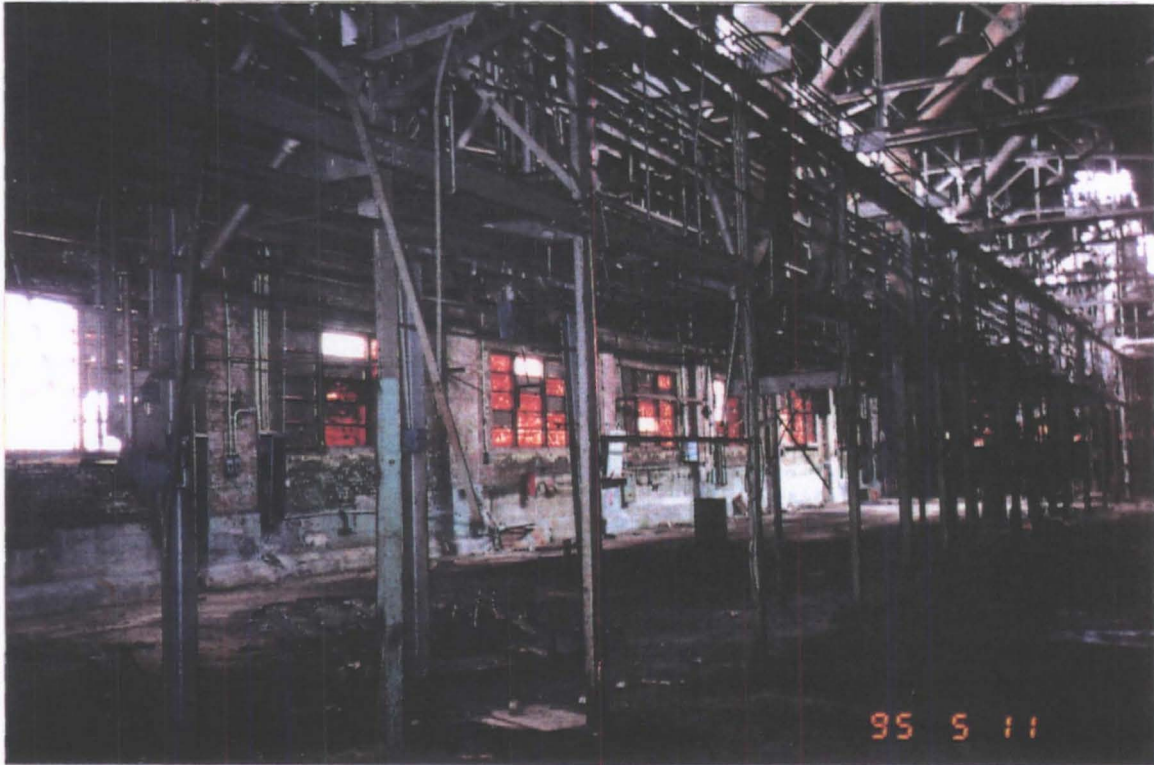
No. 5

The loading bearing masonry walls are supported by reinforced concrete foundation system consisting of a stem wall and strip footing with an integral pier and spread footing at each masonry pilaster supporting the roof truss. The top of the stem wall is approximately 8 to 10 inches above parking lot asphalt surface and 3'-5" above the finish floor elevation. (Photo No. 5)

North Die Cast Building: View looking at north exterior masonry wall through floor supported pipe rack at center of building

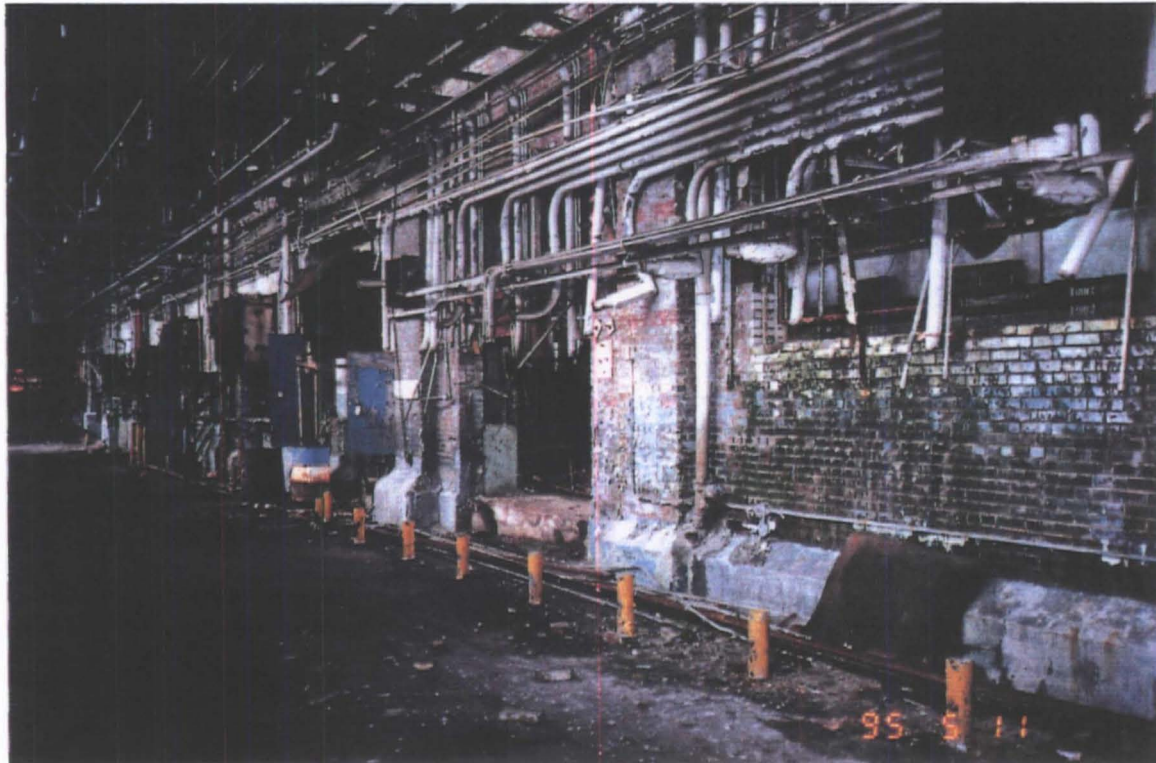
No. 6

Appurtenances, such as light fixtures, electrical conduit, fire sprinkler piping, steel angle pipe rack, and process piping were observed throughout the building. (Photo Nos. 5, 6, 7, and 8)

North Die Cast Building: View looking towards South Die Cast Building; common masonry wall, pilasters, and conduit

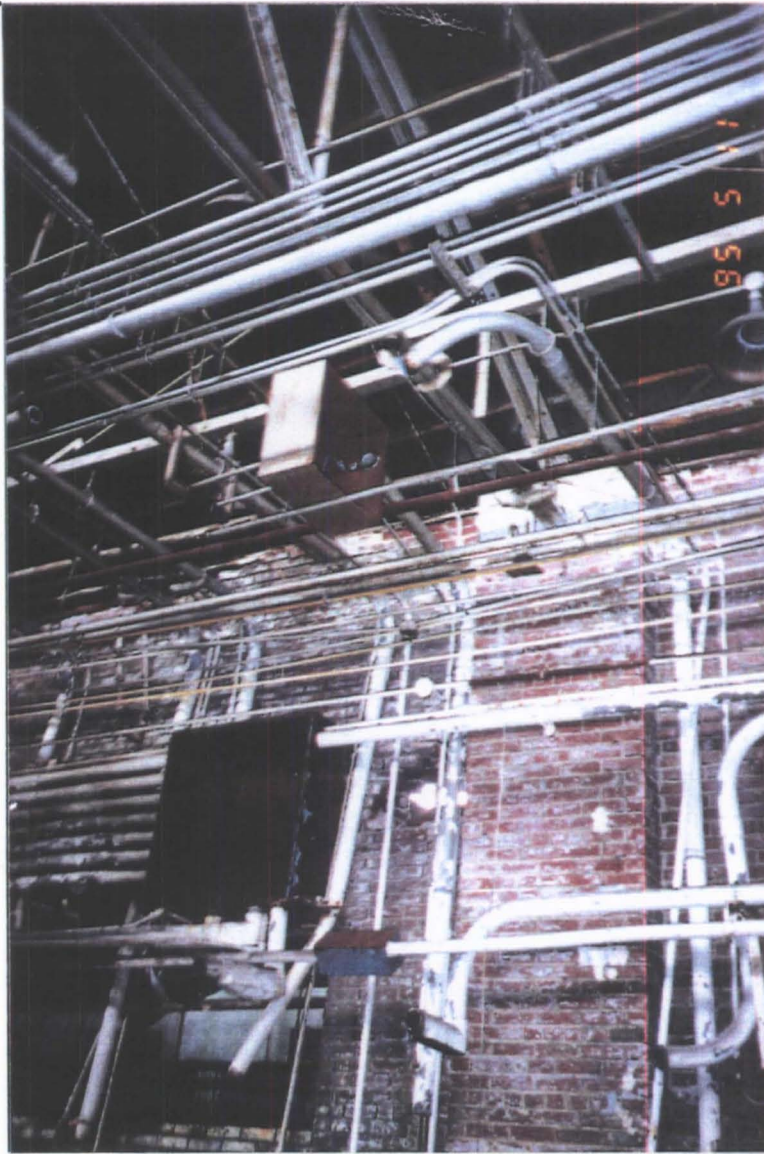
No. 7

North Die Cast Building: Steel roof truss bearing on brick masonry pilaster, piping and conduit supported from roof truss

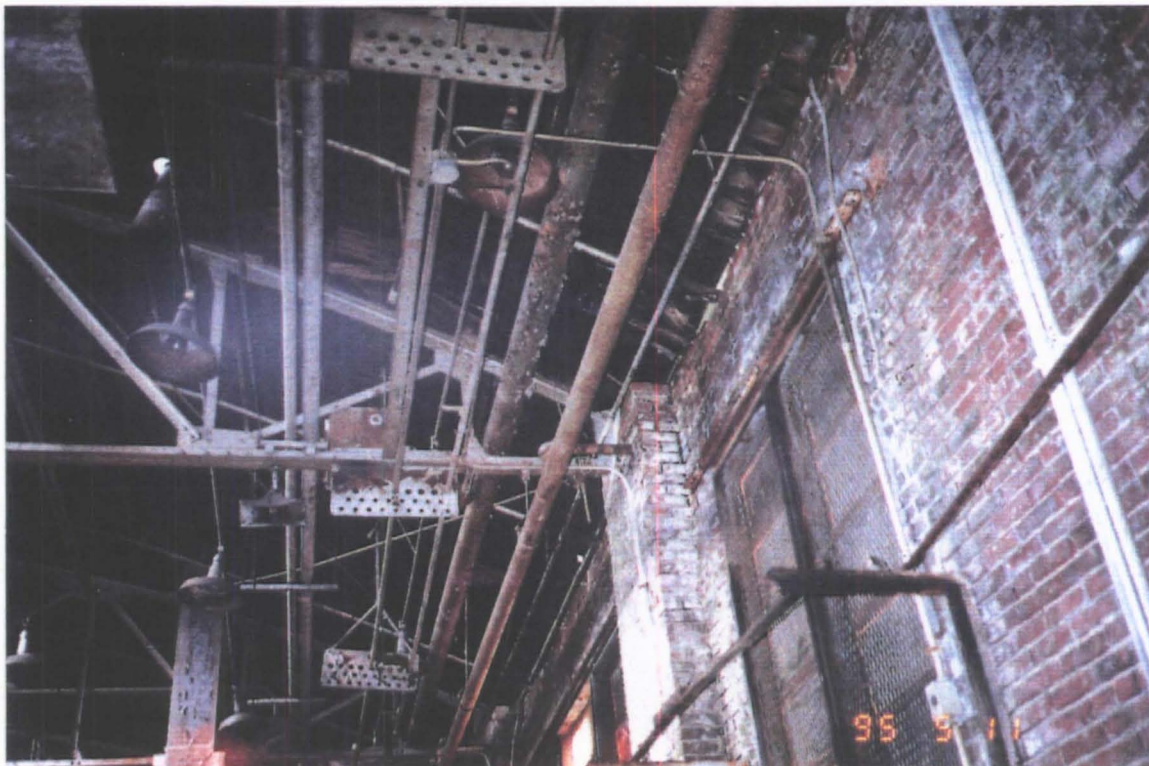
No. 8

North Die Cast Building: Steel roof truss, wood joists, and decking; piping and other appurtenances supported by roof truss

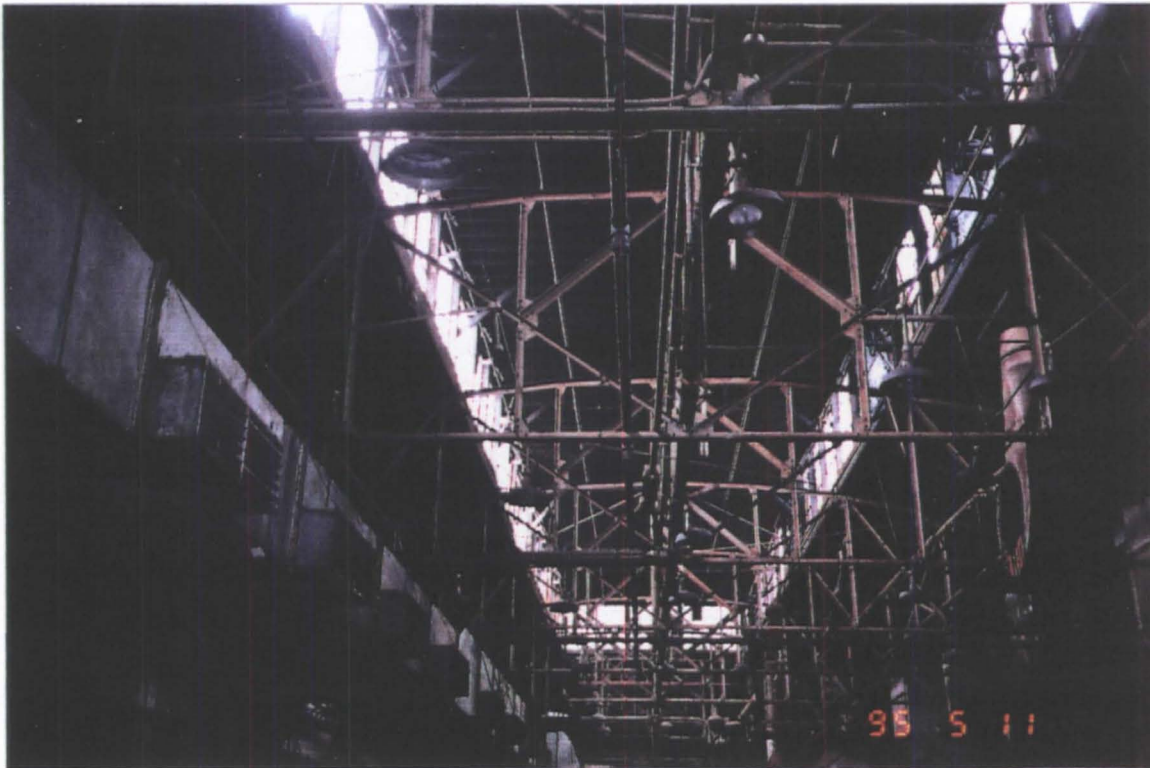
No. 9

South Die Cast Building: View looking up to clearstory through steel angle roof trusses

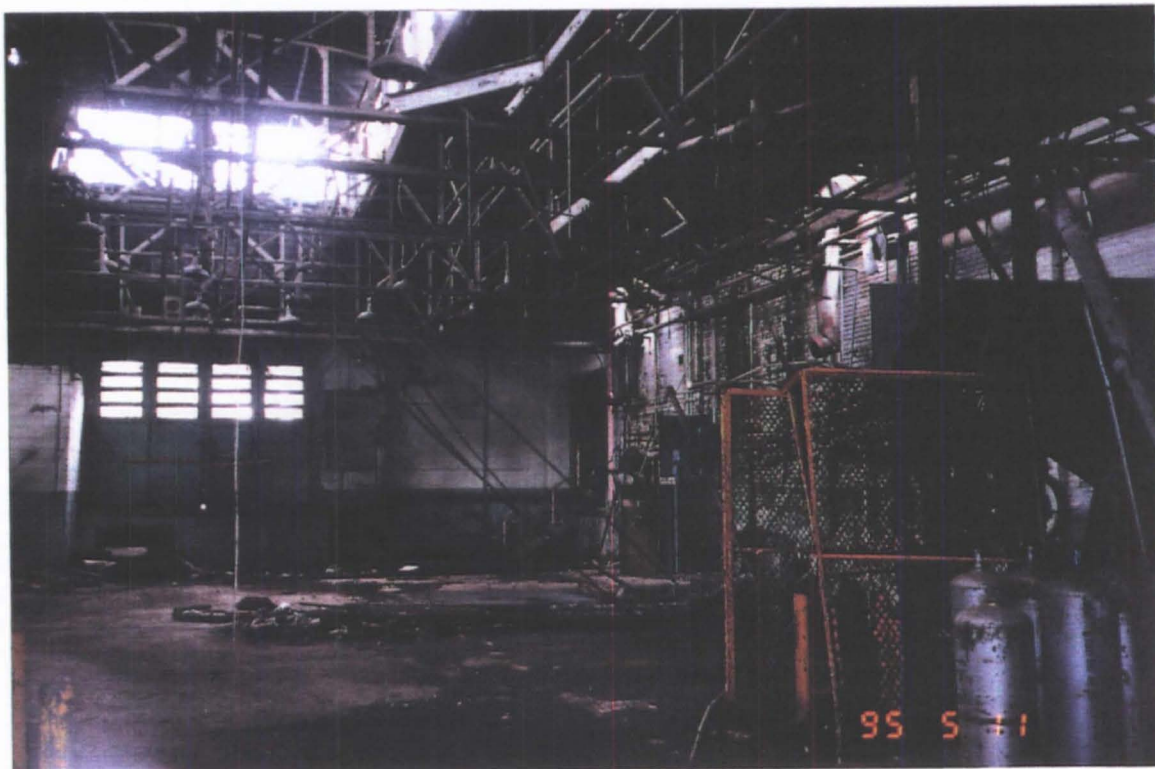
No. 10

Appurtenances, such as light fixtures, electrical conduit, fire sprinkler piping, process piping, sheet metal hoods, and abandoned floor mounted process equipment, were observed throughout the building. (Photo Nos. 9, 10, 11 and 12)

South Die Cast Building: View looking towards Grand Avenue loading dock and doors; piping, light fixtures, and other appurtenances

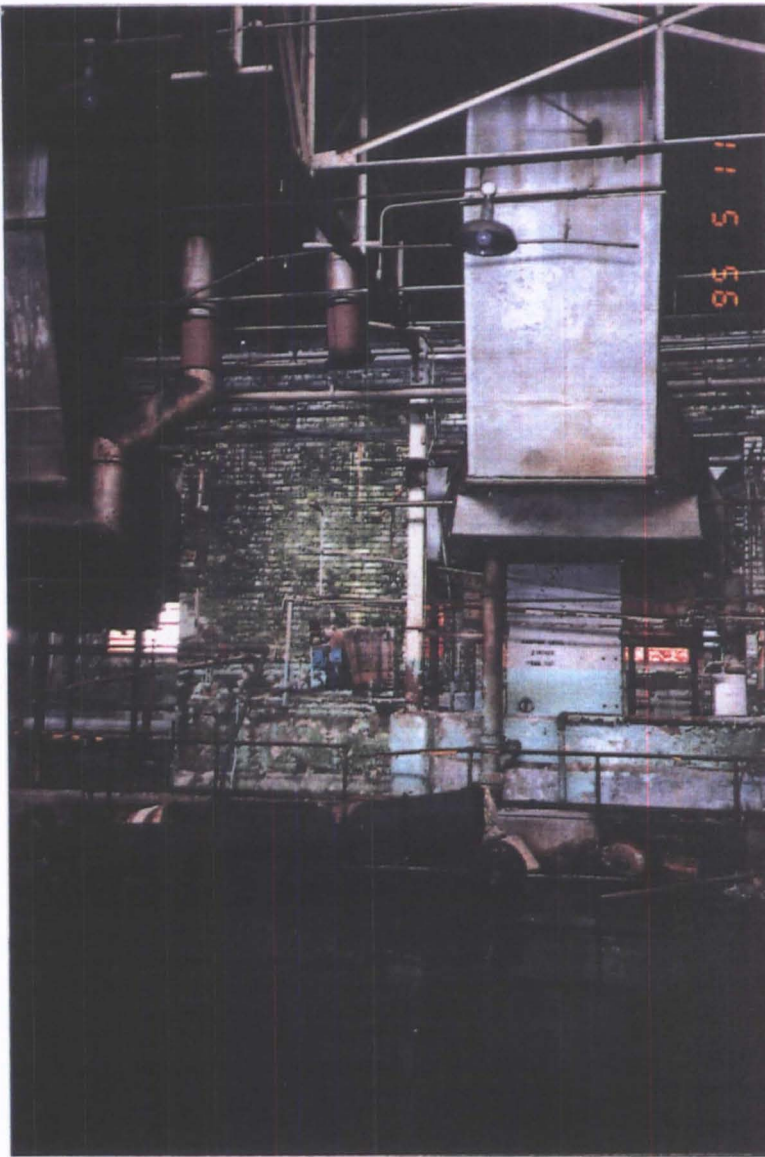
No. 11

South Die Cast Building: View looking at common wall with North Die Cast Building, concrete pier and steel column supporting steel roof truss

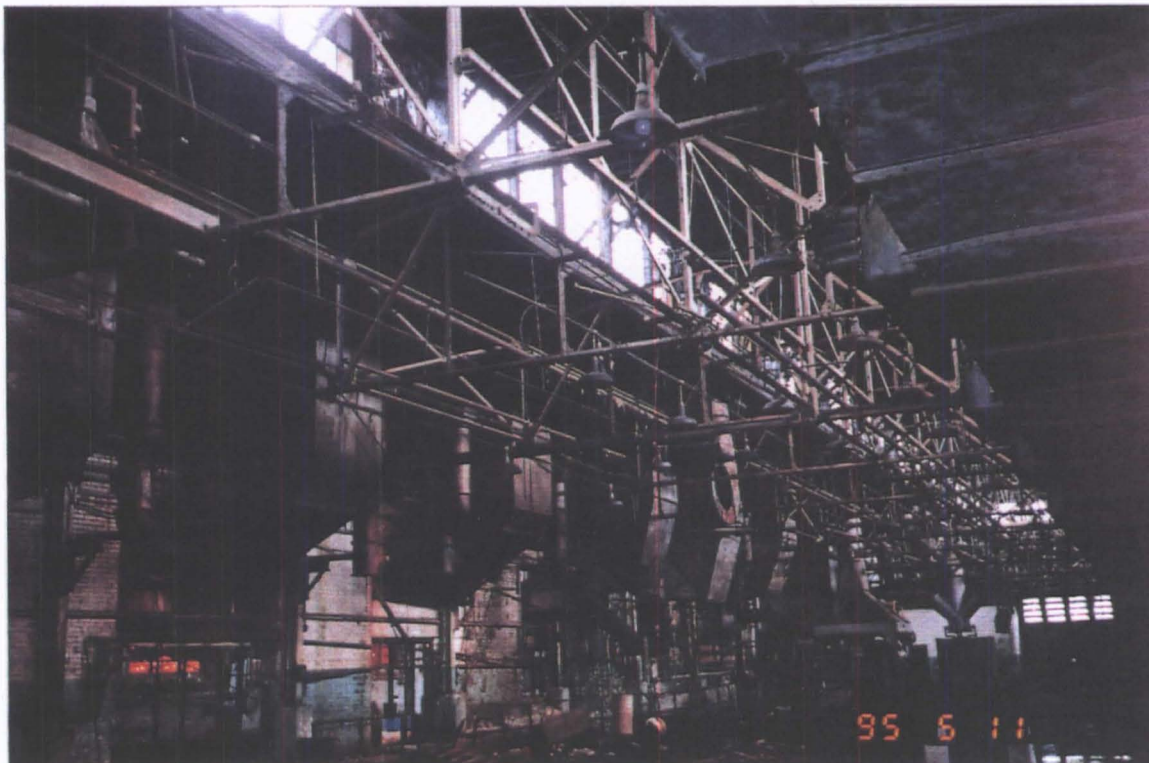
No. 12

South Die Cast Building: View looking towards Grand Avenue, steel roof trusses, steel exhaust hood, piping, conduit, etc.

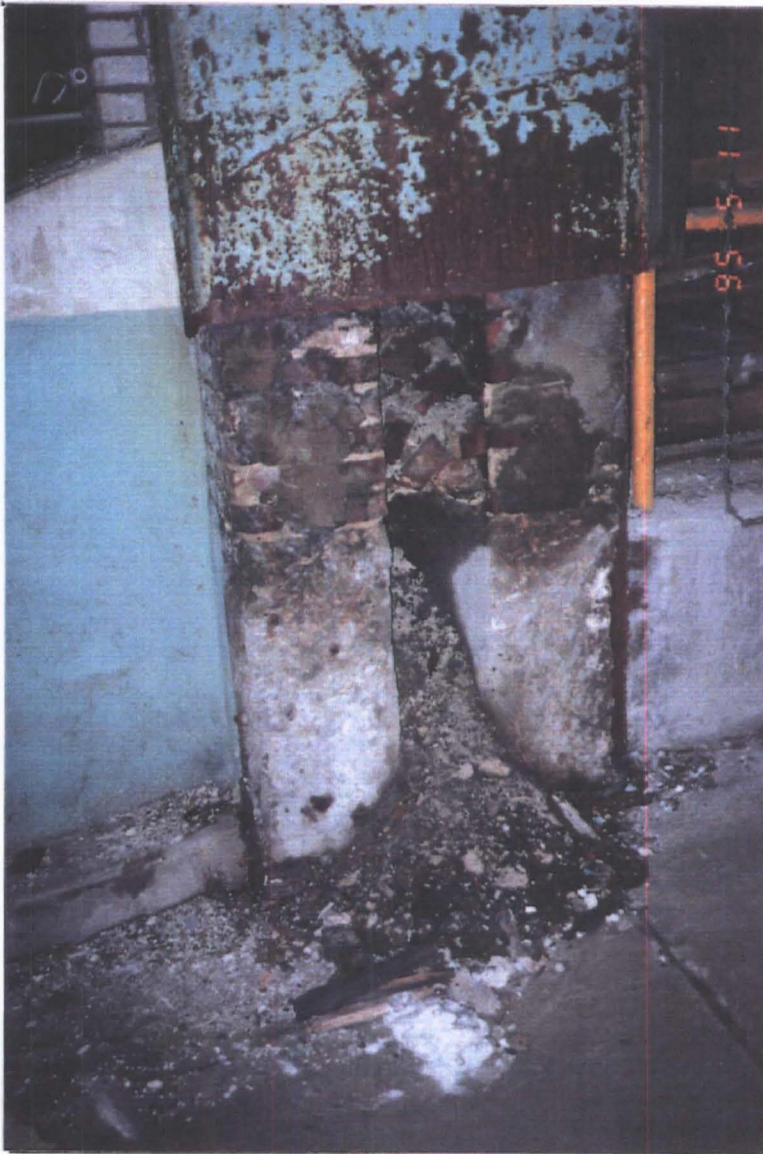
No. 13

Warehouse/Office & Shop: Brick Masonry Cavity Wall with South Die Cast Building

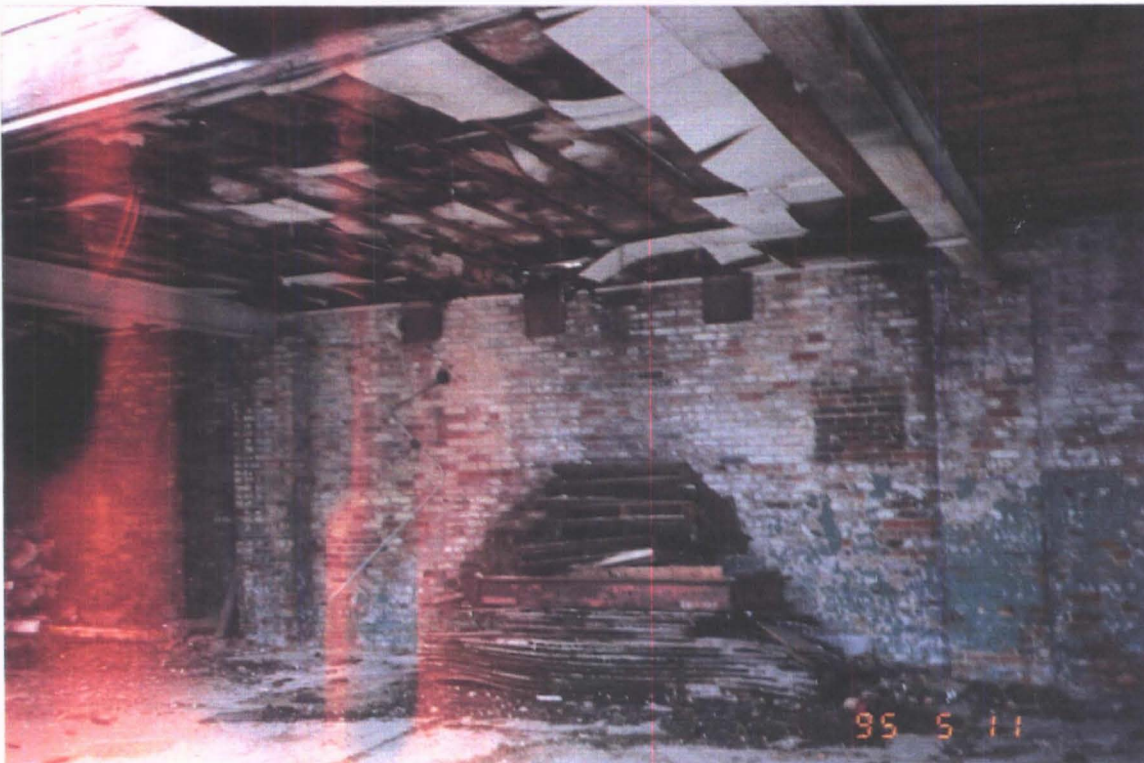
No. 14

Warehouse/Office & Shop: Brick masonry bearing wall, rolled steel beam and wood joist framing

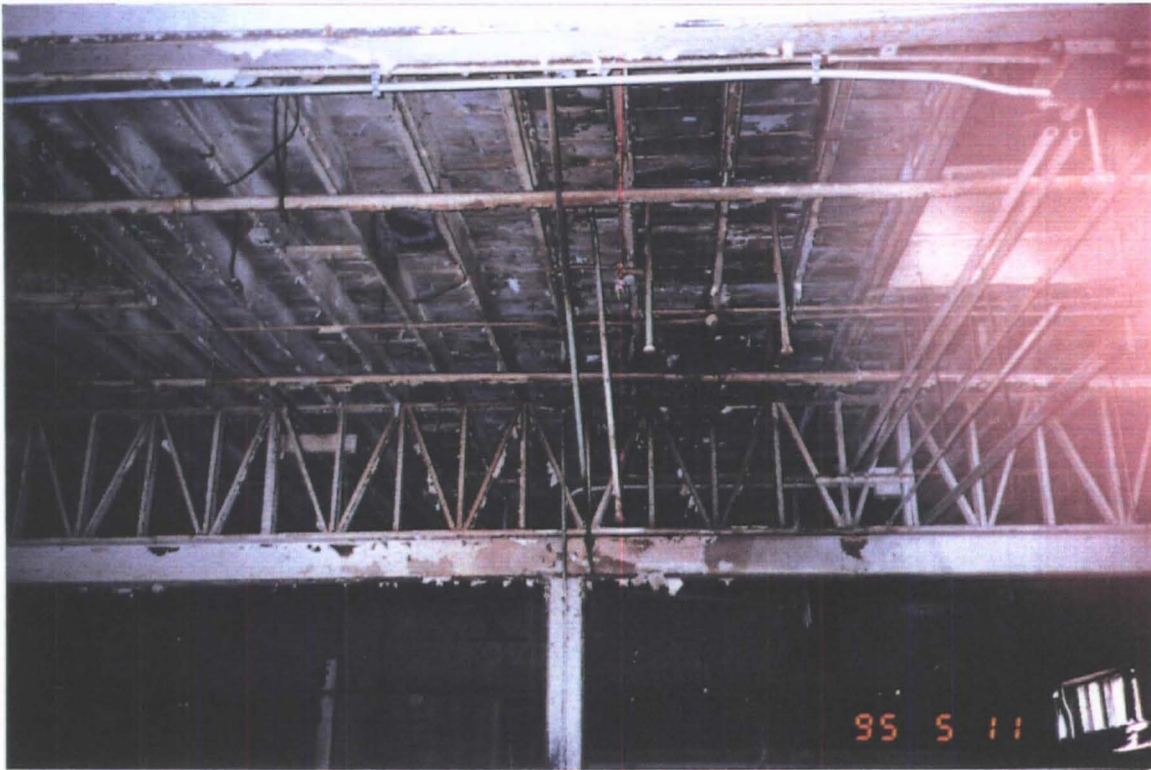
No. 15

The lateral load restraining system for the building utilizes the roof as a diaphragm transferring lateral loads to the perimeter masonry walls. (Photo No. 15)

Warehouse/Office & Shop: Rolled Steel beam and column framing with timber joists and wood board decking

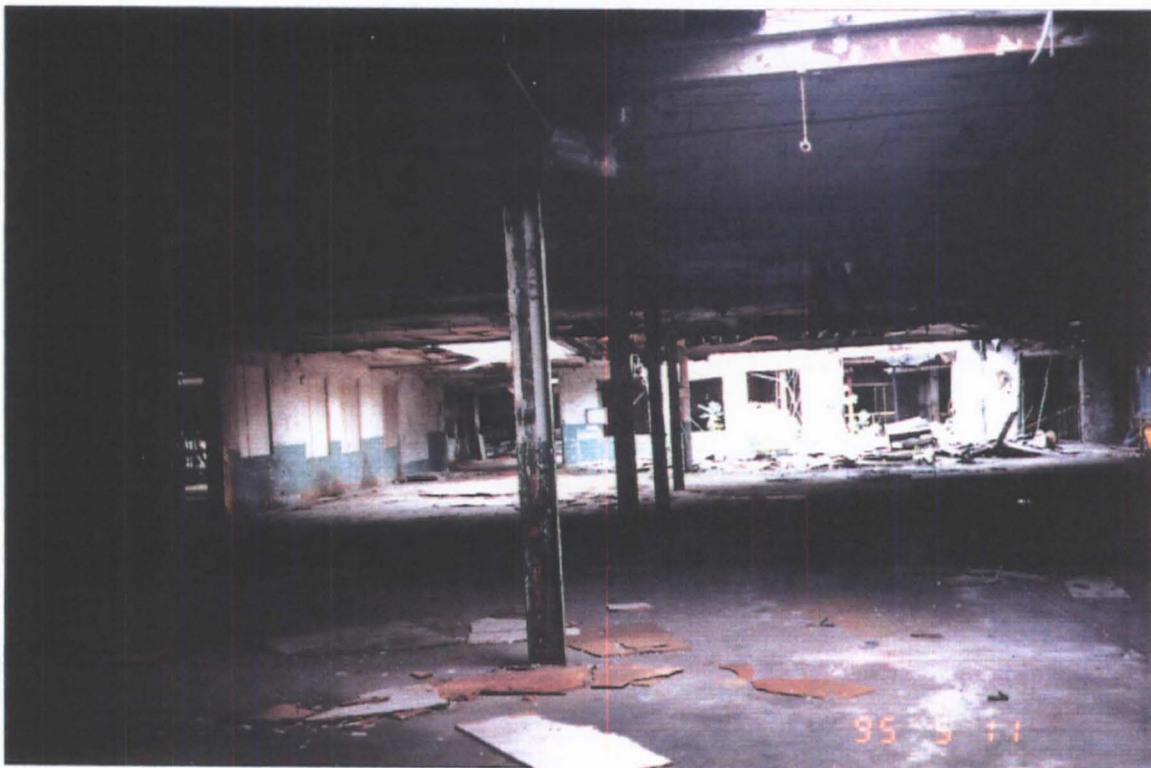
No. 16

The load bearing masonry walls are supported by a reinforced concrete foundation system consisting of a stem wall and strip footing. Each interior steel column is supported by spreading footing below the floor slab. (Photo No. 16)

Warehouse/Office & Shop: Interior view of steel column and fallen ceiling panels on floor

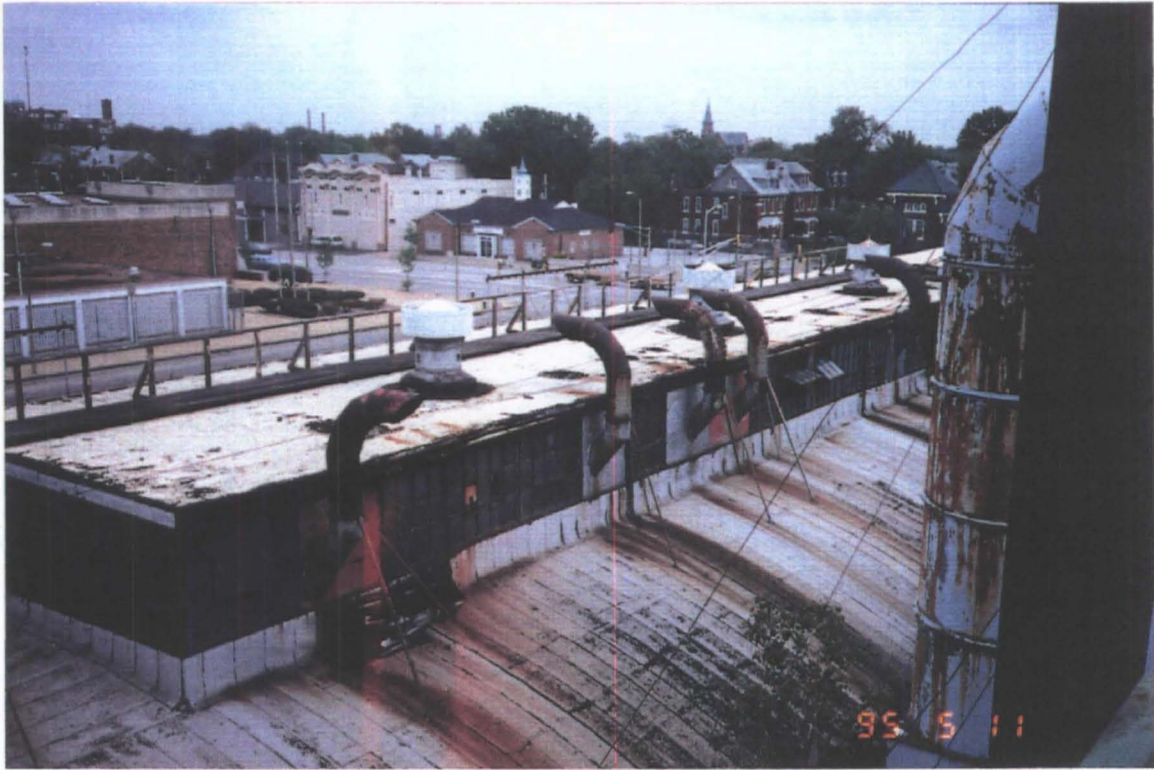
No. 17

The roof framing for the clearstory show signs of sagging, and has collapsed in the vicinity of the third truss spacing from Grand Avenue. The roof substrate and framing at top of masonry also shows evidence of deterioration, such as missing fascia boards and substrate, and exposed roof joists at the eave edge. The roof substrate and framing do not appear to be in serviceable condition to provide a watertight building. (Photo Nos. 2 and 17)

North Die Cast Building: Roof and clearstory with vent hoods penetrating roof

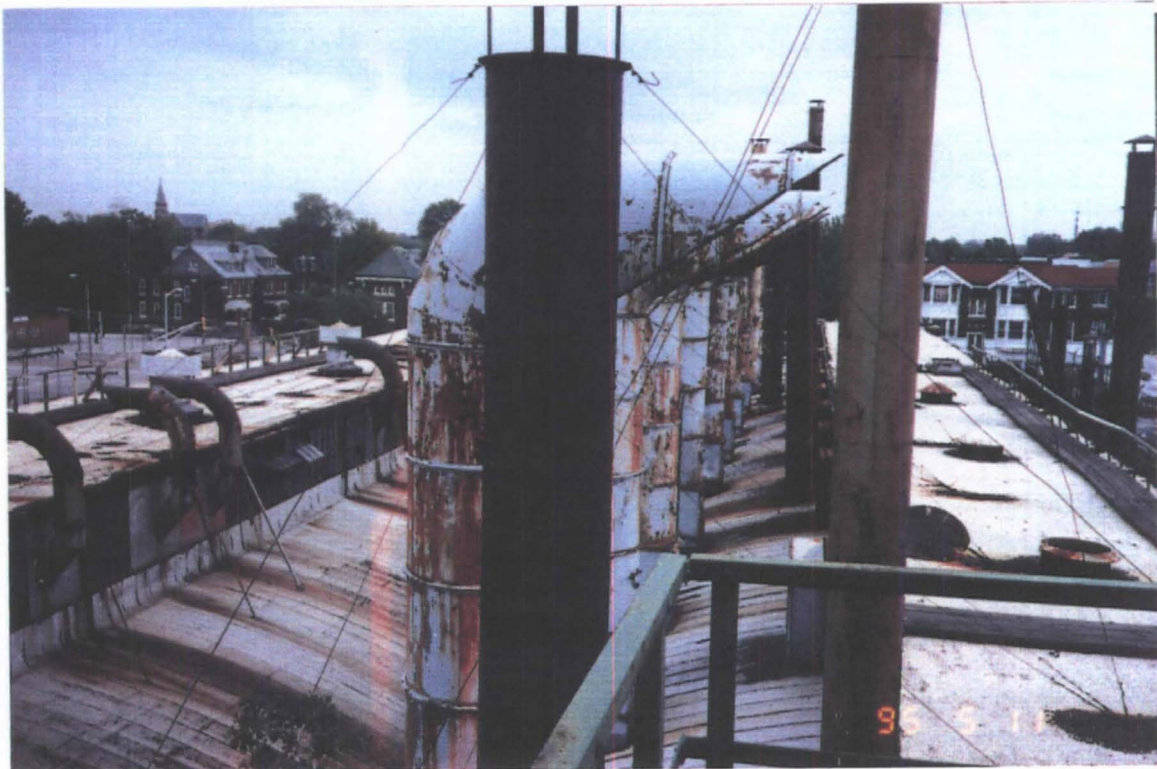
No. 18

The roof framing for the clearstory show signs of sagging and rotting. No collapse of the clearstory roof framing has occurred at the time visual observations were made. The roof substrate and framing do not appear to be in serviceable condition to provide a watertight building. Major repair and replacement would have to be undertaken to have a serviceable roof system. (Photo Nos. 18 and 19)

South Die Cast Building: Clearstory roof and cupolas and stacks penetrating roof

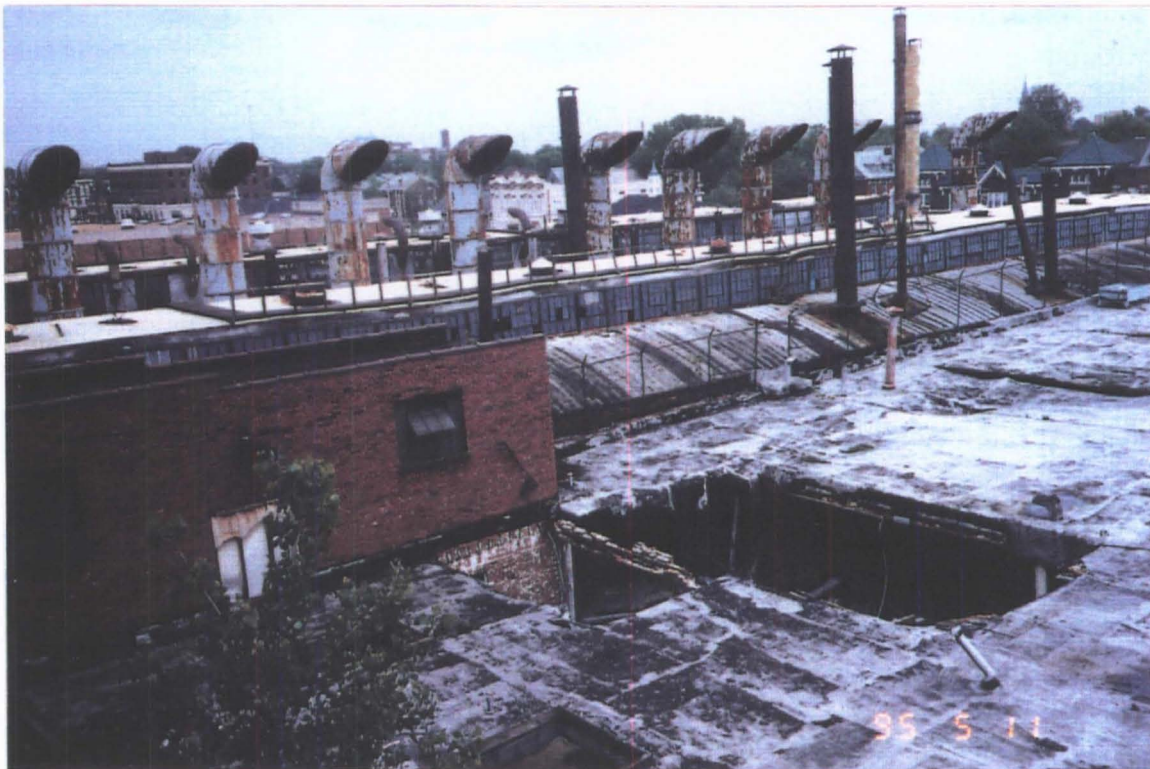
No. 19

The roofing substrate and framing shows signs of sagging and in some areas it has collapsed. Major repair and replacement would have to be undertaken to restore building to serviceable condition. (Photo Nos. 19 and 20)

Warehouse/Office & Shop (foreground): Collapsed roof, South Die Cast Building (Background); cupolas and stacks penetrating roof

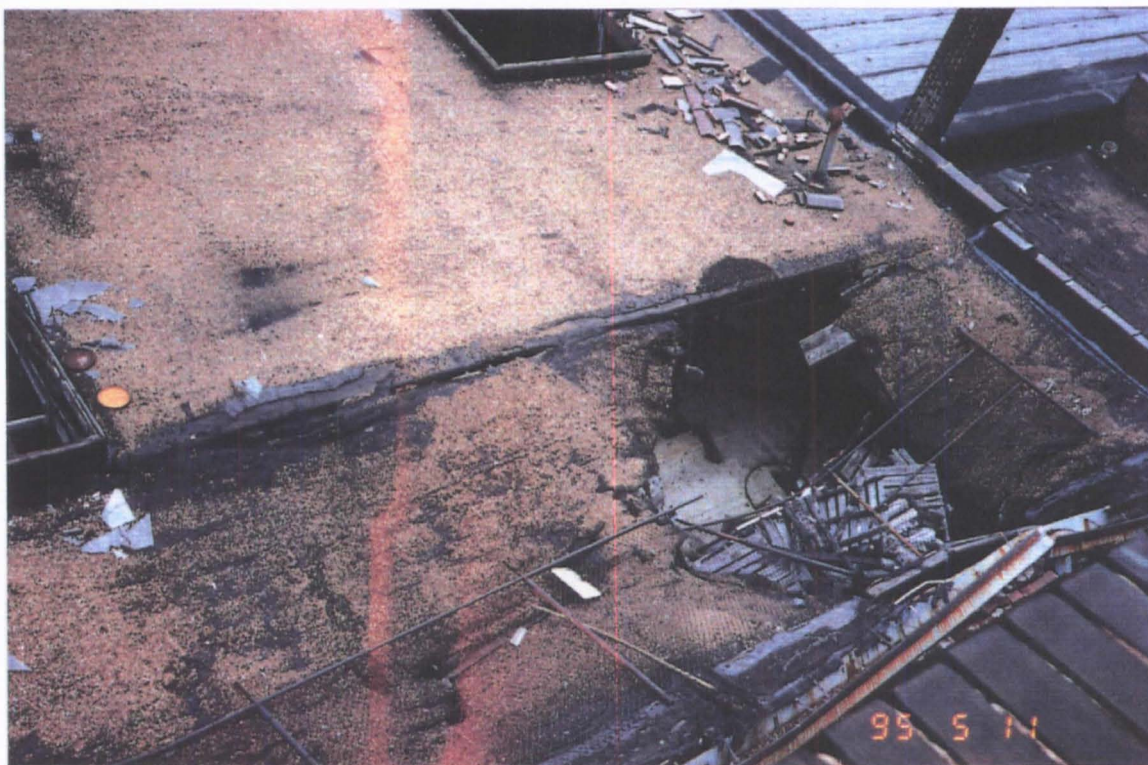
No. 20

Warehouse/Office & Shop: Skylights with glazing missing and collapsed roof
